Manhole Inspection Summary

Manhole # S15GG_002MH

Insp Date: **2/27/08 12:30 PM**

Location Address: **REAR OF 2720 BAKER ST**

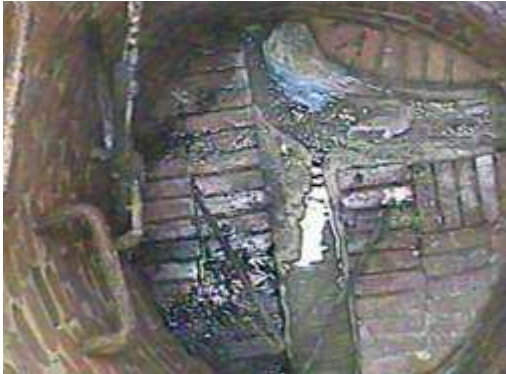
Defect 2

☒ **Evidence Of Surcharge** Depth: **1** (ft.) ☐ Active Surcharge Present

evidence surcharge

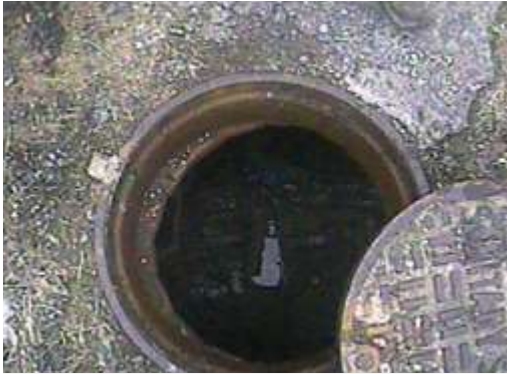
Defect 1

Offset: **2** (in.)

Condition: ☐ Sound ☐ Cracked ☐ Root Intrusion ☒ **Loose Brick** ☐ Deteriorated

offset frame and loose bricks frame adjustment

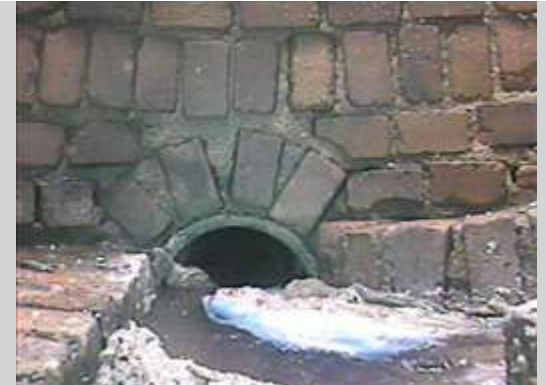
12 O'Clock Outflow

Pipe Height: (in.) Direct
Pipe Material: **Clay** ☐ Pipe Lined
Invert Depth: **6.92** (ft.) Flow Characteristics: **Fast**
Deposits: ☐ None ☐ Mud ☐ Sludge ☒ **Debris** ☐ Grease
Silt Depth: **4** (in.) Deposits Extent: **Medium**
Infiltration: **None** Pipe Seal Cond: **Sound**

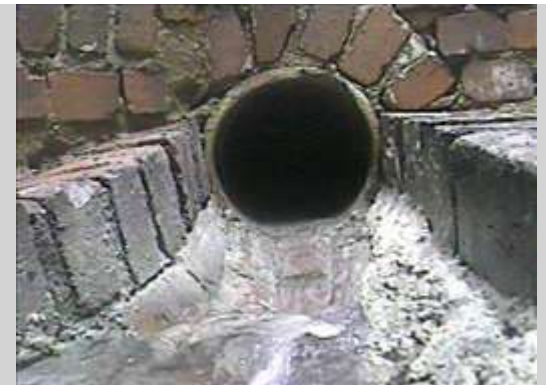
3 O'Clock Inflow

Pipe Height: (in.) Direct
Pipe Material: **Clay** ☐ Pipe Lined
Invert Depth: **6.80** (ft.) Flow Characteristics: **Fast**
Deposits: ☒ **None** ☐ Mud ☐ Sludge ☐ Debris ☐ Grease
Silt Depth: (in.) Deposits Extent:
Infiltration: **None** Pipe Seal Cond: **Sound**

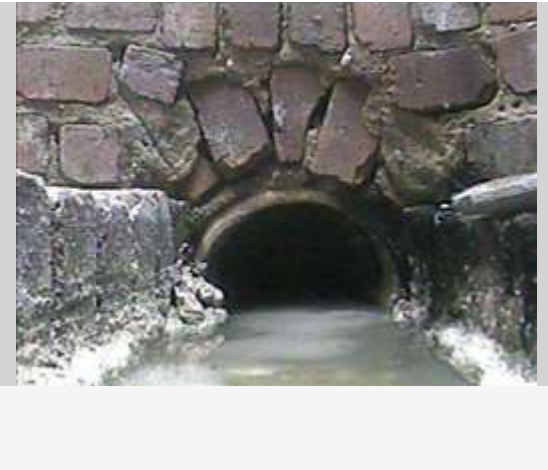
6 O'Clock Inflow

Invert Depth: **6.89** (ft.) Flow Characteristics: **Slow**

Connects To: **House connection / Service line**
